# Inspection Report

## All Alert Home Inspections

3735 Allie Rd  
Greenville, Georgia 30222  
County: Meriwether

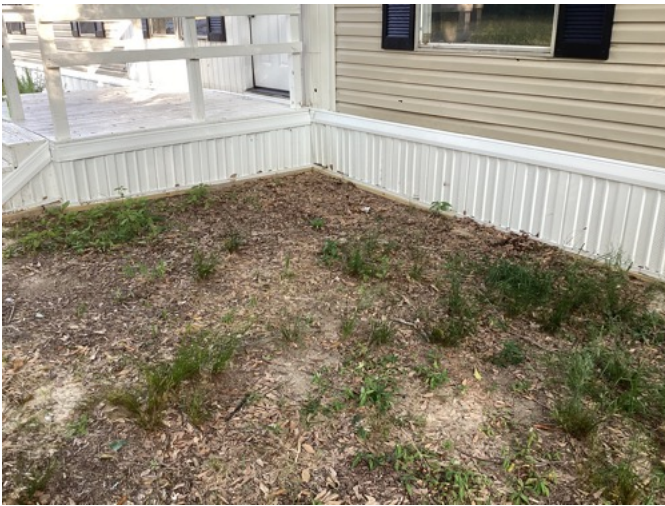
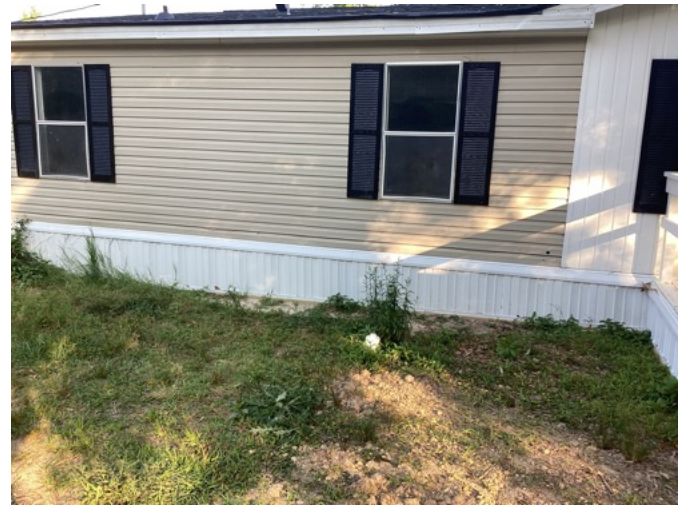
#### 1.1) Grading Conditions

Signs of soil erosion or depressions were observed in some areas. Recommend filling in the area(s) as needed to prevent potential trip hazard and to insure that all water drains away from the house to prevent water related issues at the foundation, crawl space, and or basement.

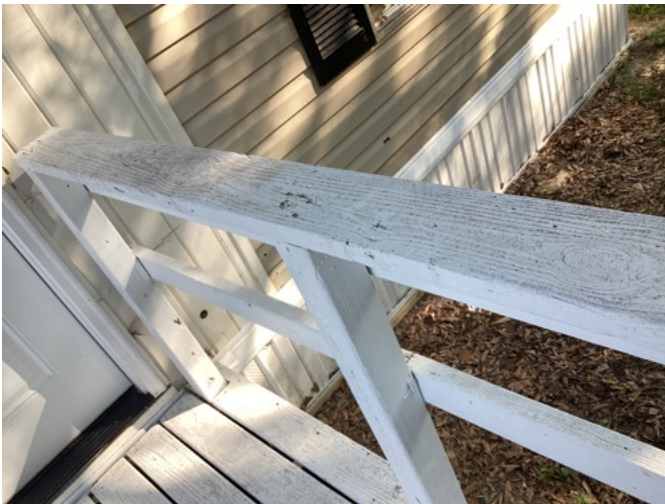
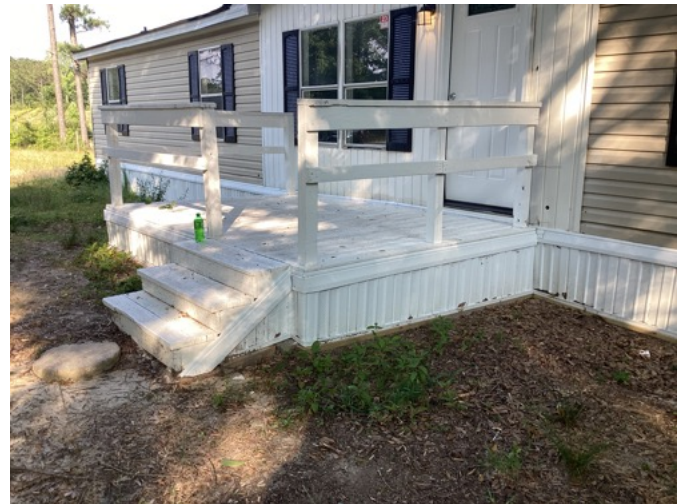
2.1) Front Entrance Conditions

Weathered and rough deck surfaces were noticed. Correct this as warranted for it's intended purpose and to prevent further damage.

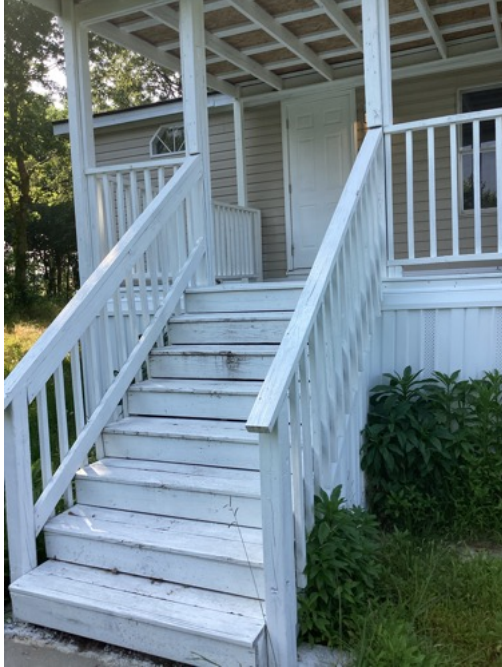
2.2) Back Entrance Conditions

Weathered and rough deck surfaces were noticed. Correct this as warranted for it's intended purpose and to prevent further damage.

Noticed wood in direct contact with the ground around the house and decks. Wood in direct contact with the soil will cause eventual wood rot damage, pest activity damage (termite). Providing clearance to prevent wood to soil contact is recommended to avoid damage.

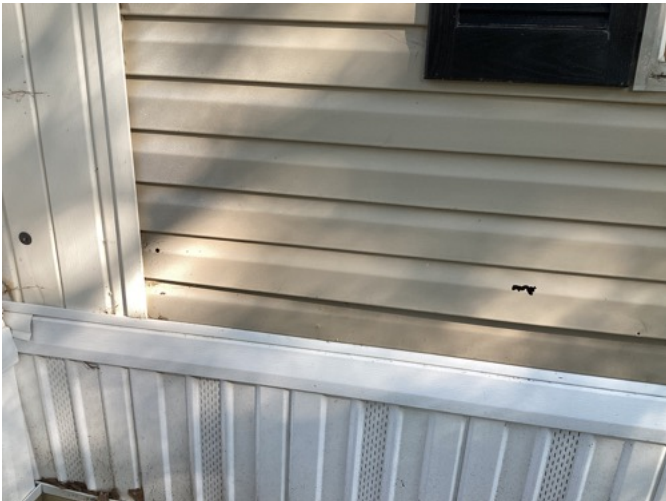
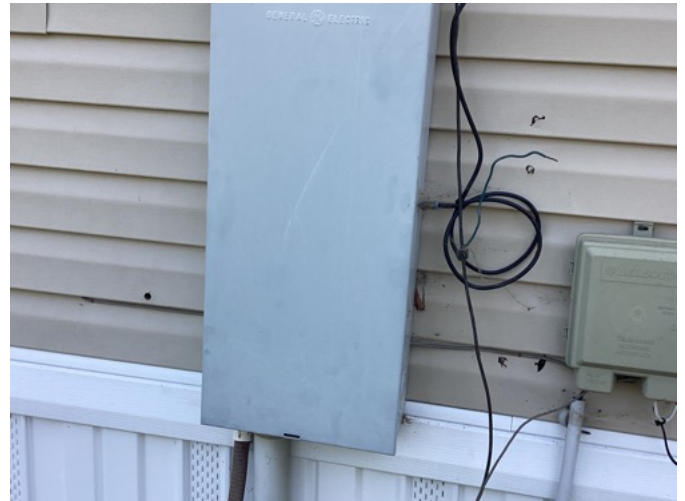
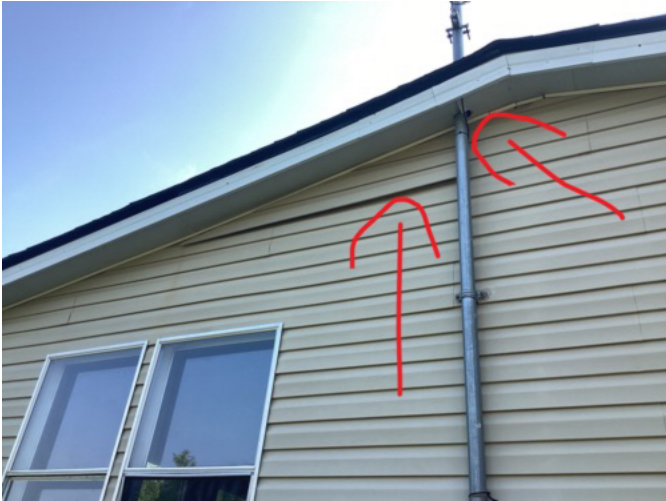
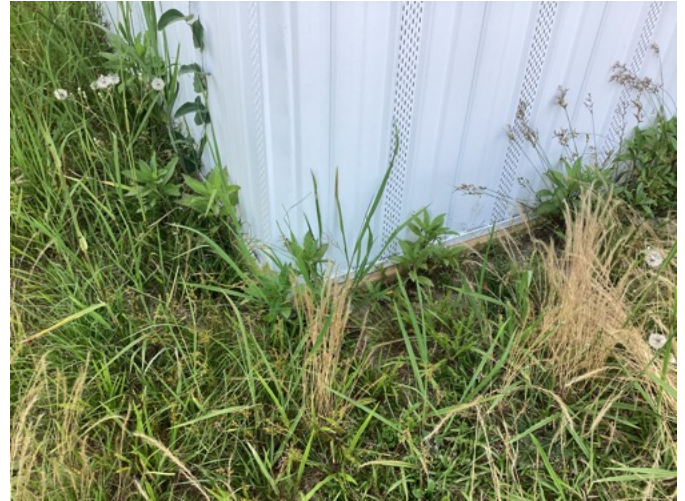
**2.3) Exterior Wall Conditions**

Openings were noticed in siding. Seal and or repair / replace as needed to prevent moisture intrusion and pest activity and damage.

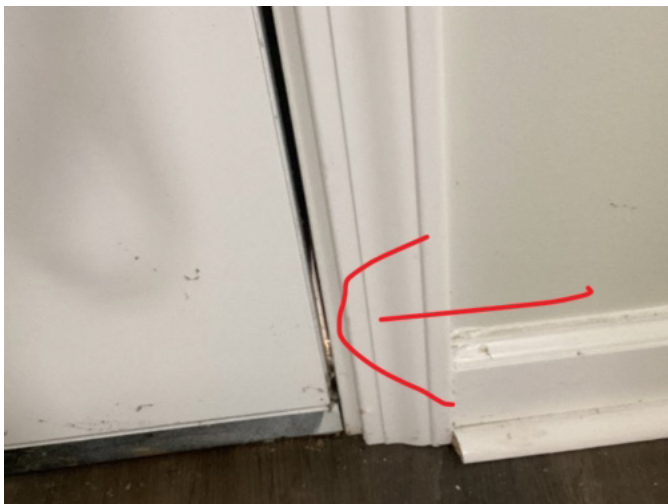
**2.6) Exterior Door Conditions**

Front door, Opening(s) were noticed between the door and door frame. Recommend adjusting door, weather stripping, or adding or replacement of weather stripping to seal openings to prevent moisture intrusion and pest activity.

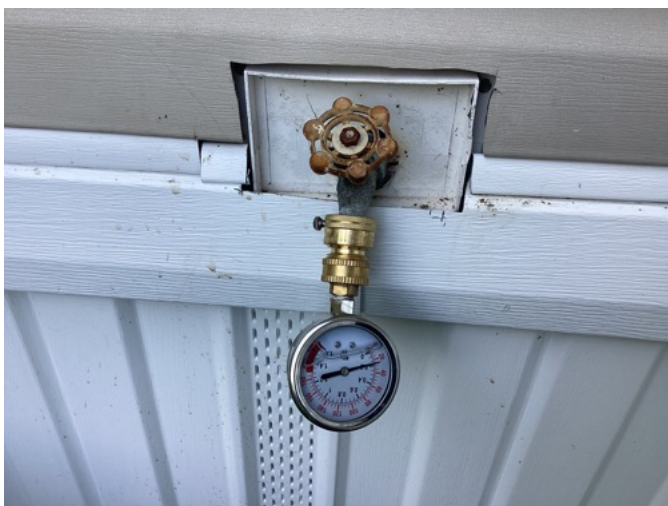
2.7) Faucet Conditions

Hose Bibb was loose at the wall. Have this repaired to prevent damage and for proper functionality.

Low water pressure was noticed at spigot. Have this corrected by a licensed plumber for proper functionality.

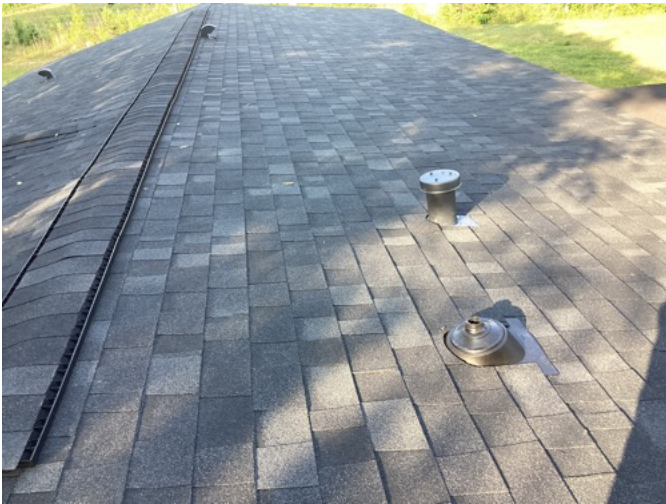
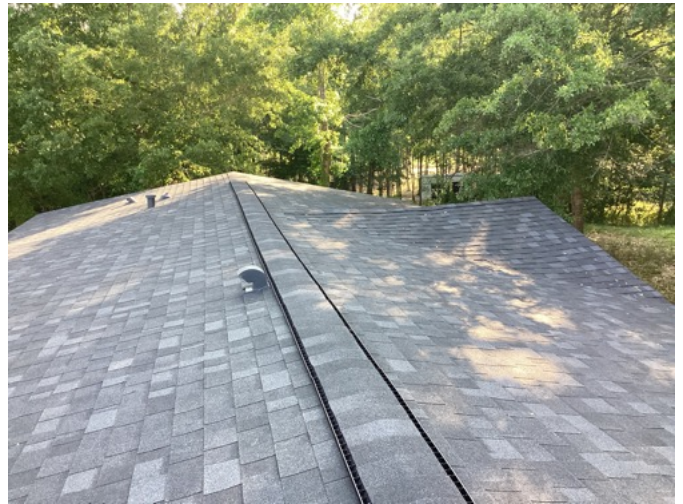
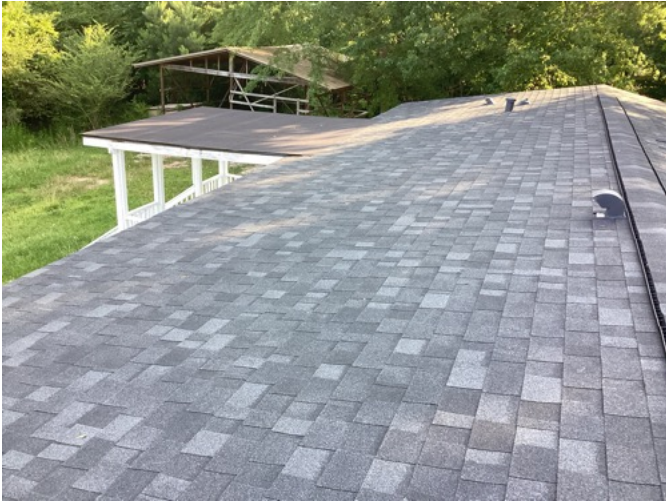
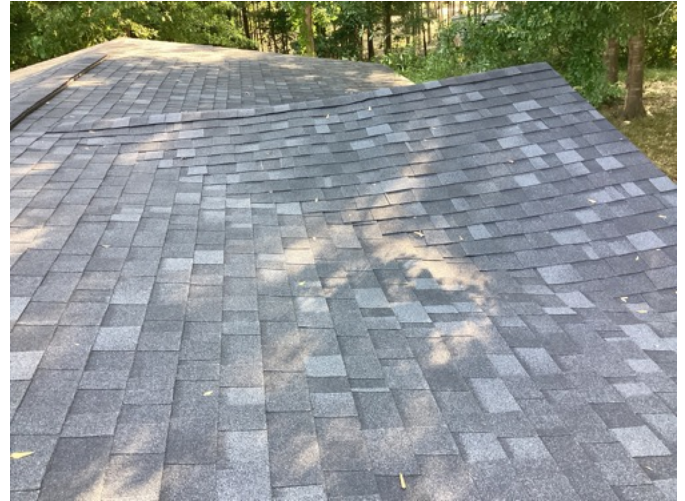
**3.1) Roof Covering Condition**

Minor sagging or depressions were observed to the roof sheathing and / or framing support. There is no damage; however, when viewing the roof wavy type appears is noticeable

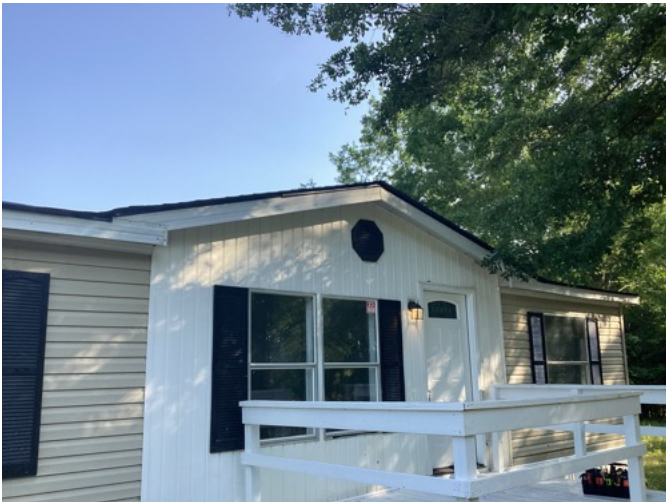
**3.3) Gutter & Downspout Conditions**

The property has a no gutter system installed. Recommend adding gutters and downspouts where needed. Water seepage into crawl spaces, basements and under foundations are primarily caused by inadequate removal of rainwater from the perimeter of the house.

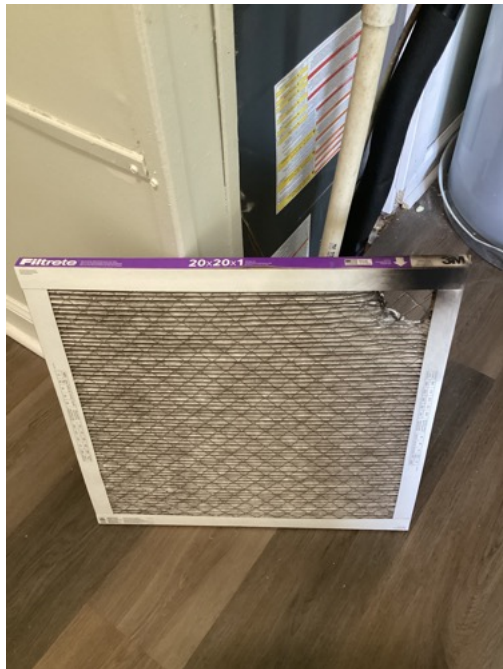
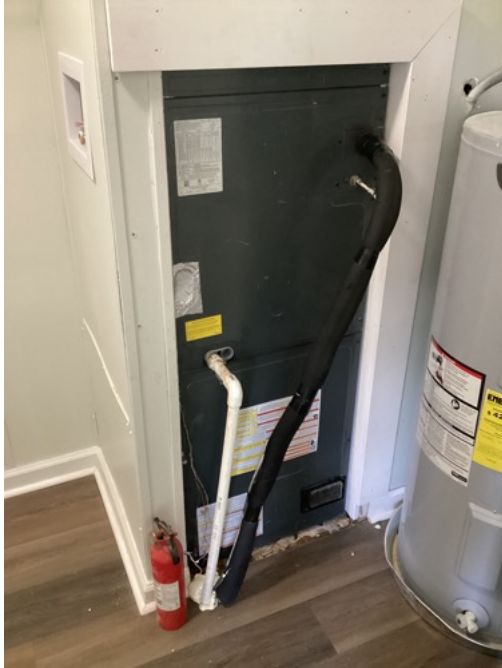
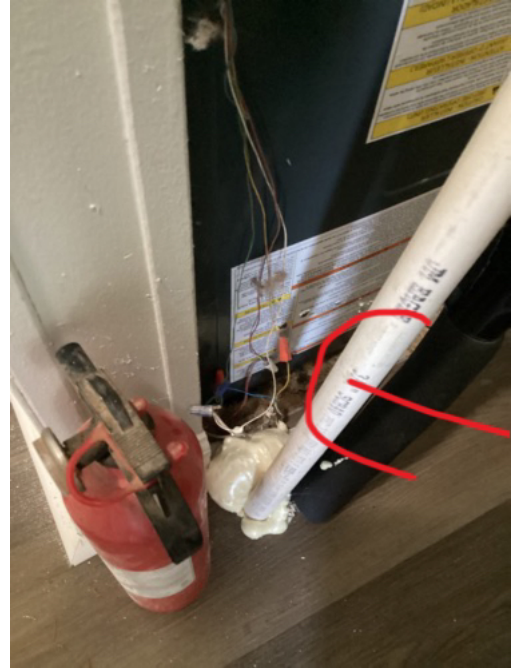
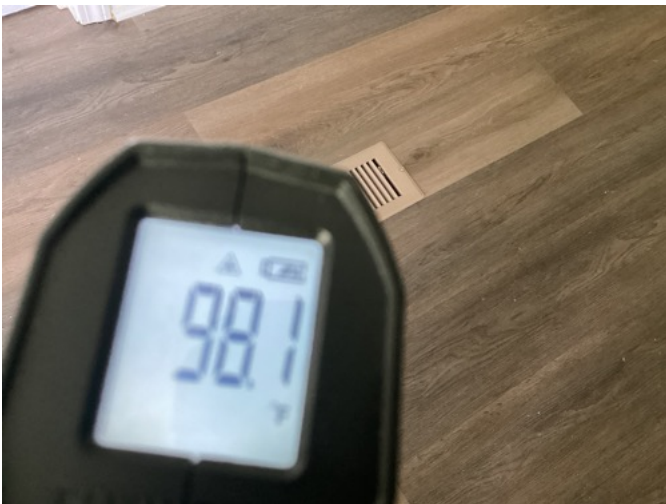
**4.1) Unit Conditions**

2021 Amana fan coil unit.  
 Air filter was dirty and damaged. Recommend replacing for proper air flow and efficiency. 20 x 20 x 1.  
 There was no secondary drain pan installed under the furnace. Consider installing one to prevent water related issues inside of the house should the unit leak water due to condensation and or a clogged condensation drain line.  
 Exposed electrical wire fasteners and or exposed wires were noticed at furnace or fan coil areas. Have this corrected by a licensed electrician for electrical safety.  
 The heating system was operational at time of inspection. This is not an indication of future operation or condition.

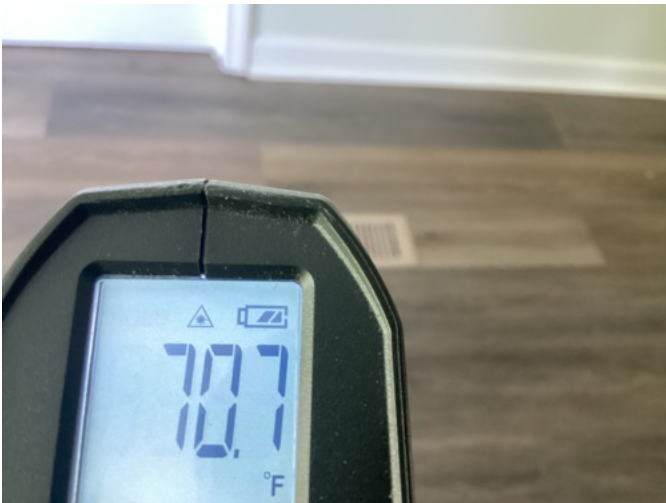
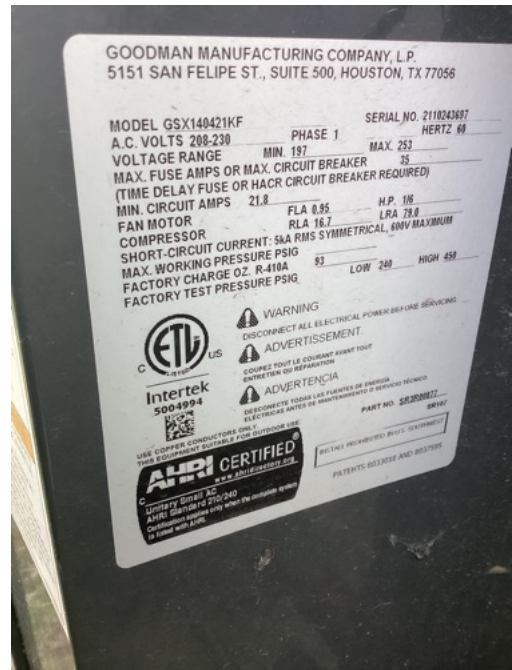
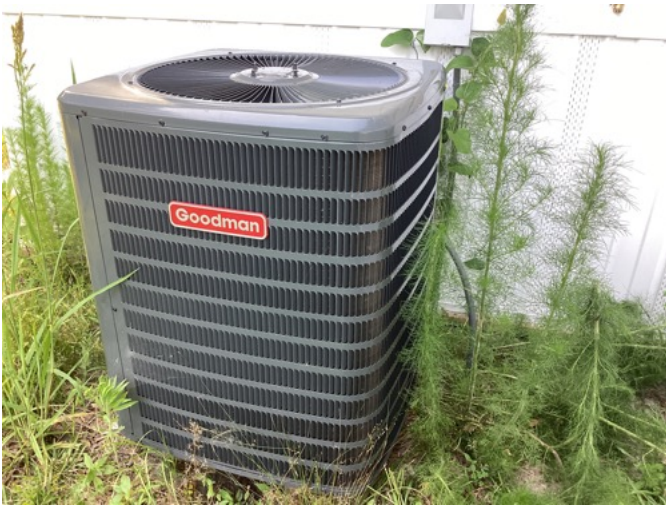
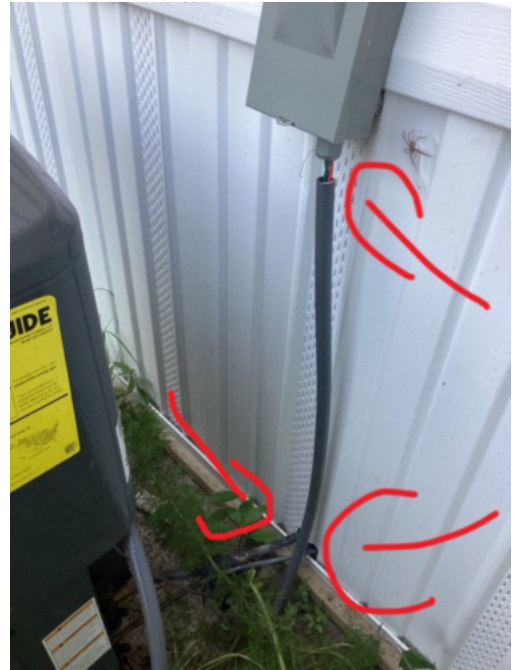
4.5) AC Unit Conditions R

2021 Goodman 3.5 ton Heat pump condenser unit.  
 Insulation for a/c suction refrigerant line is damaged or missing. Recommend repairing to prevent condensation, moisture related issues, and efficiency.  
 Recommend sealing where A/C and or lines and or electrical wires penetrate the wall(s), flooring, etc. to prevent moisture intrusion and pest activity in the crawl space and or house.  
 Electrical cable was loose. Have this corrected for electrical safety and proper functionality.  
 The A/C unit was not operable at the time of inspection. Recommend further evaluation by a qualified HVAC contractor prior to close.

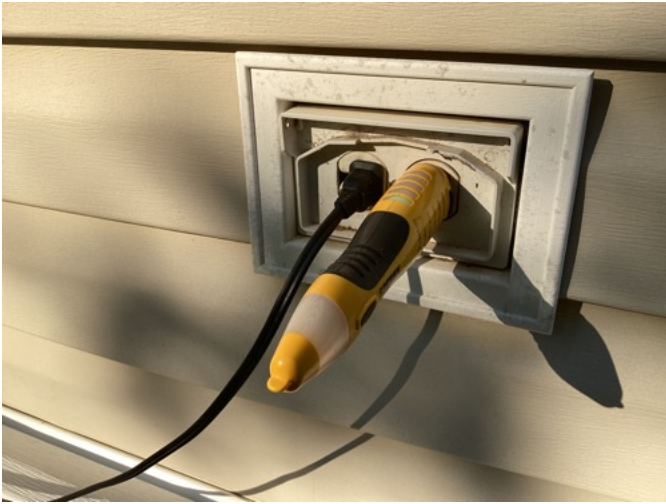
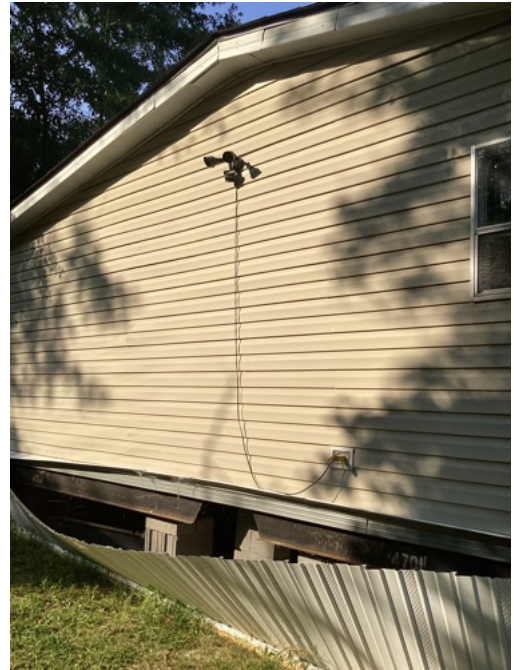
Outlet at is not gfcı protected and or will not reset. Have repaired by a qualified electrician for electrical safety.

Electrical plate that covers electrical wires is damaged or missing and or electrical whip is loose and or not properly attached. Have this corrected by a licensed electrician for electrical safety.

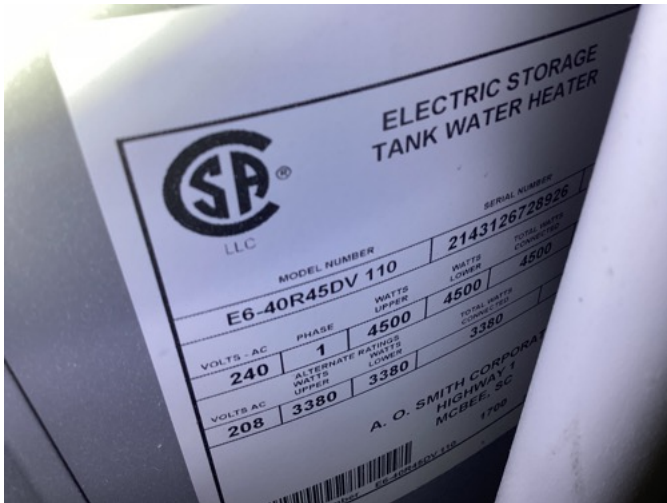
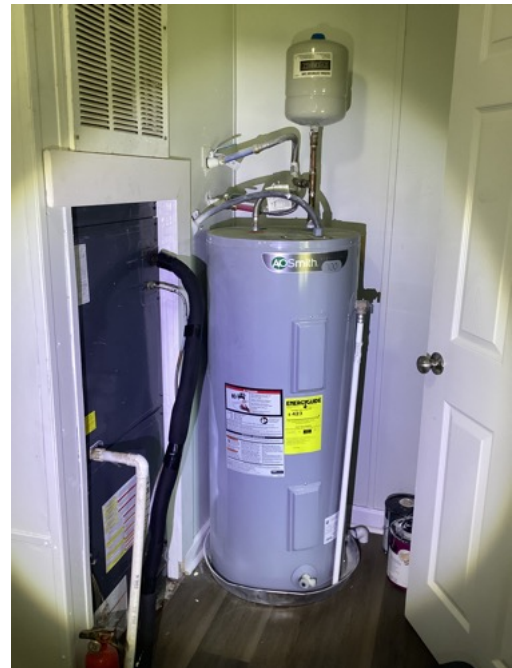
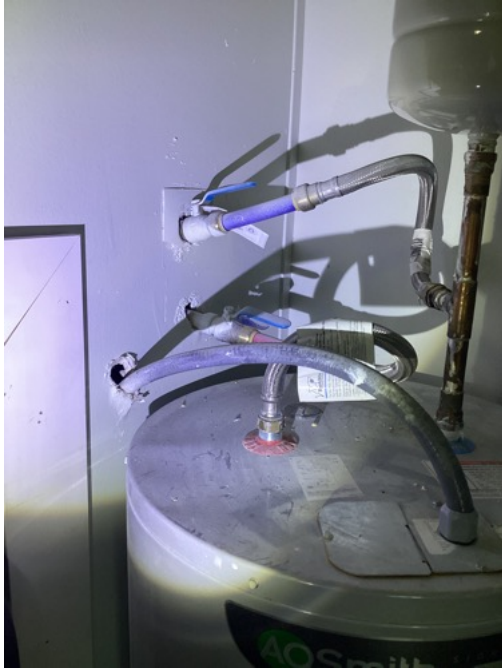
**6.4) Water Heater Conditions** R

Cracks, damage, openings around flue vent, etc. we're noticed at the time of the inspection.

Recommend properly sealing all openings to prevent moisture intrusion and pest activity.

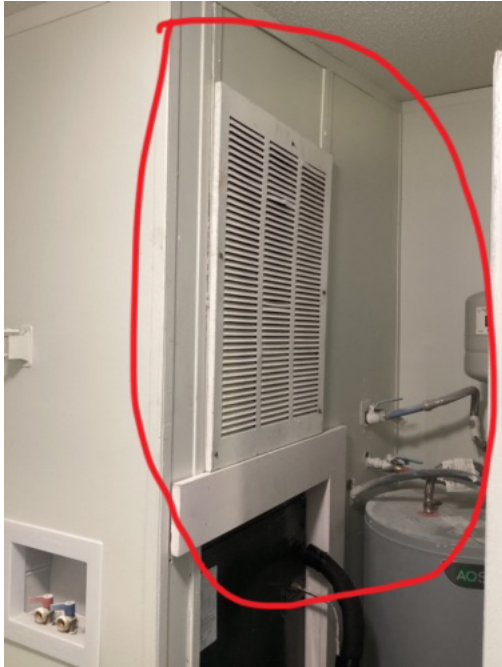
#### 7.1) Wall Conditions

Wall is weak. Have this repaired by a licensed contractor for proper functionality.

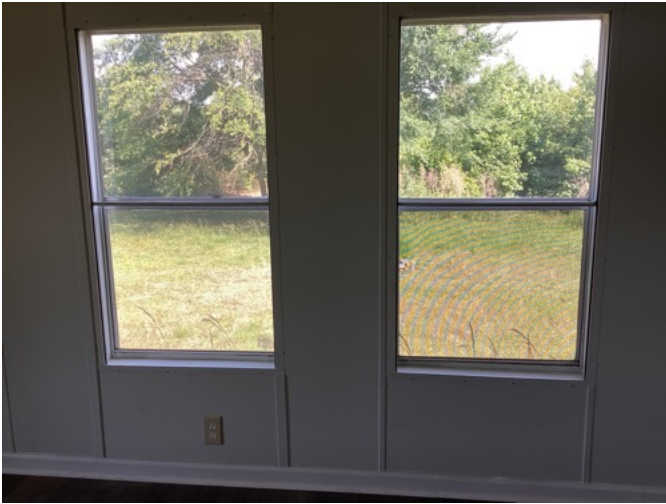
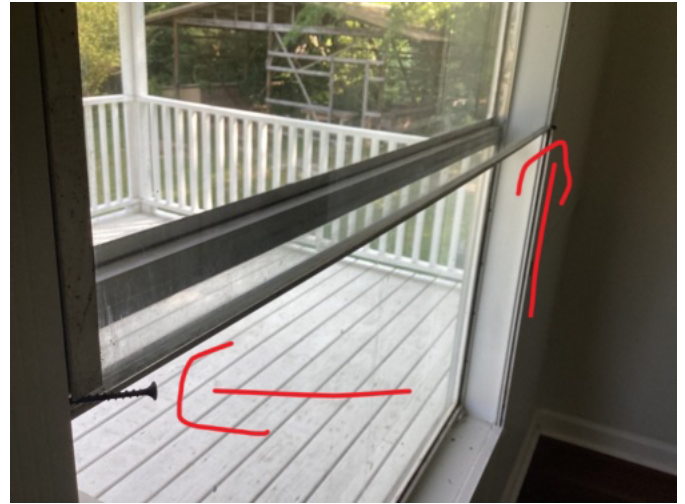
#### 7.5) Interior Window Conditions

Family and dining room, Noticed (4) inner windows were missing from dining room windows.

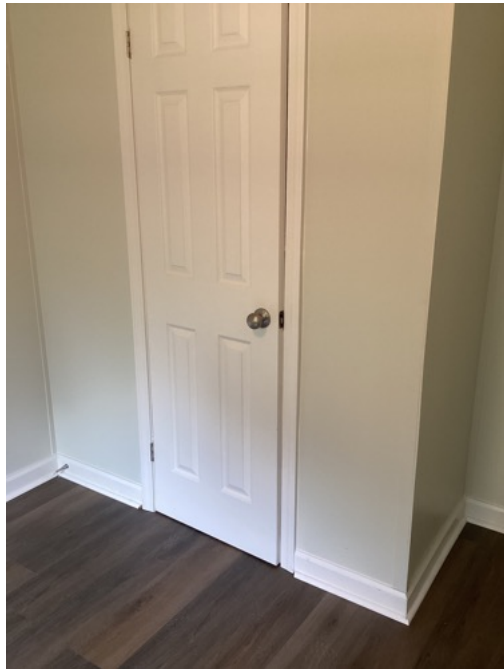
7.6) Interior Door Conditions

Front left closet bedroom door, middle bedroom door, When closing the door it binds, sticks, and or is not in line to properly latch.

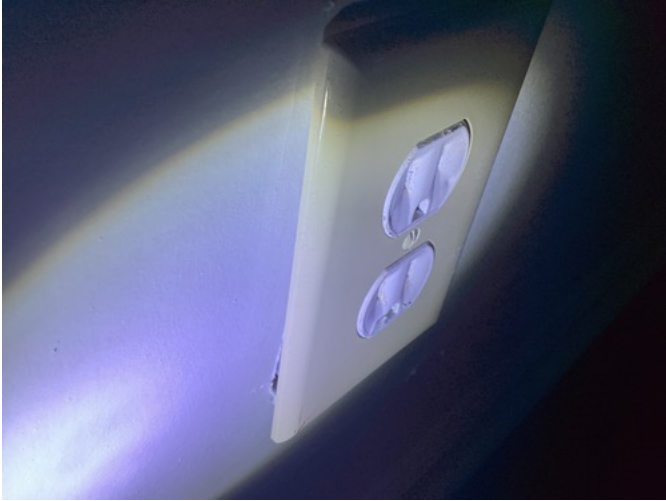
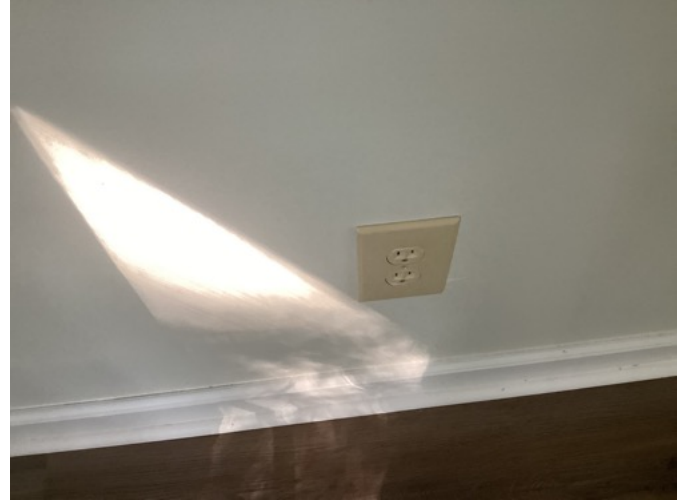
7.7) Electrical Conditions

Family room, Loose receptacle(s) and or electrical cover. Have this repaired by a licensed electrician to prevent electrical shock injuries.

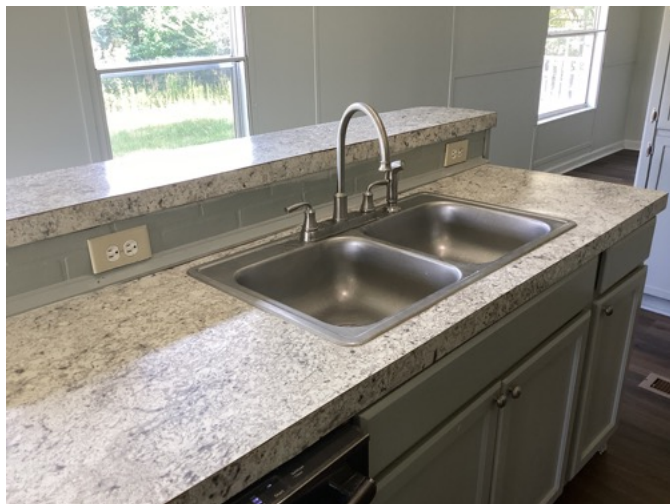
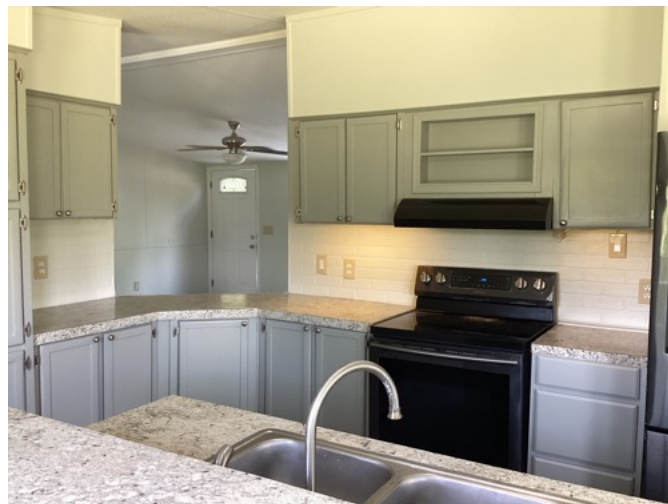
**Electrical Conditions****8.7) Electrical Conditions**

Receptacle is not gfci protected and or will not reset. Have this corrected by a licensed electrician for electrical safety.

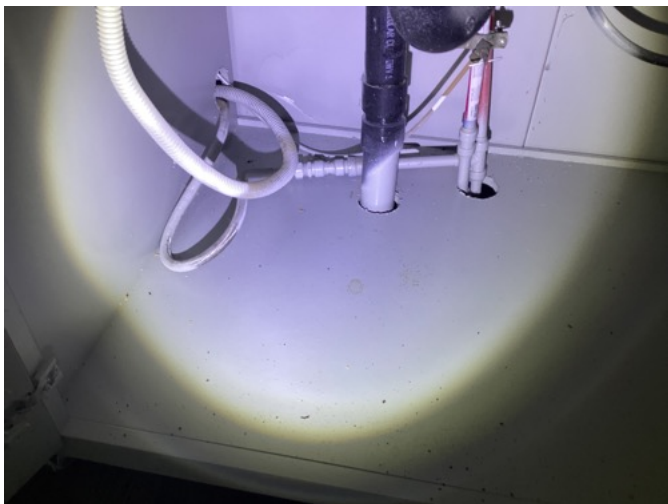
**8.11) Cabinet Conditions**

Seal openings where pipes go through the wall or cabinet under sink to prevent moisture intrusion and pest activity.

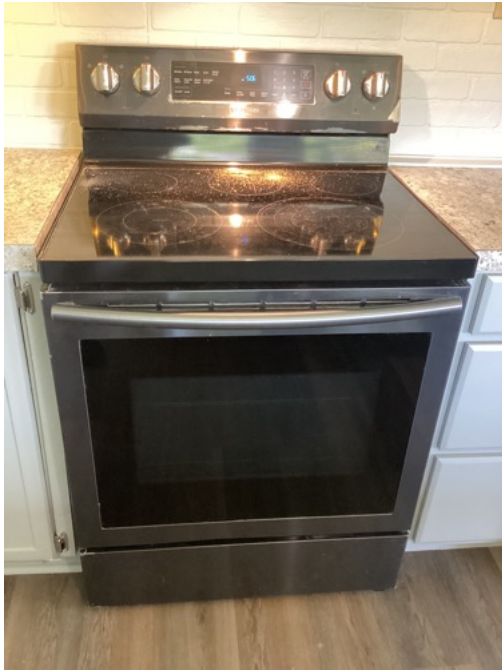
**8.14) Stove - Range Condition**

Install anti - tipping bracket to prevent the oven from tipping over on someone when excessive force is applied to oven door.

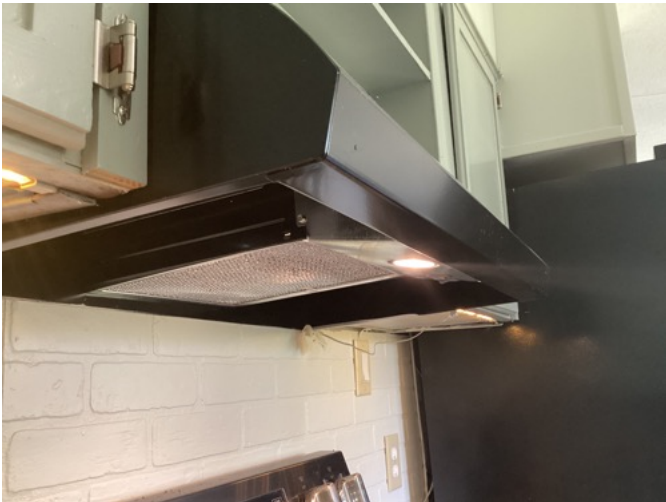
#### 8.15) Hood Fan Conditions

The fan was noisy at the time of inspection. Recommend adjustment and/or repair and / or replacement.

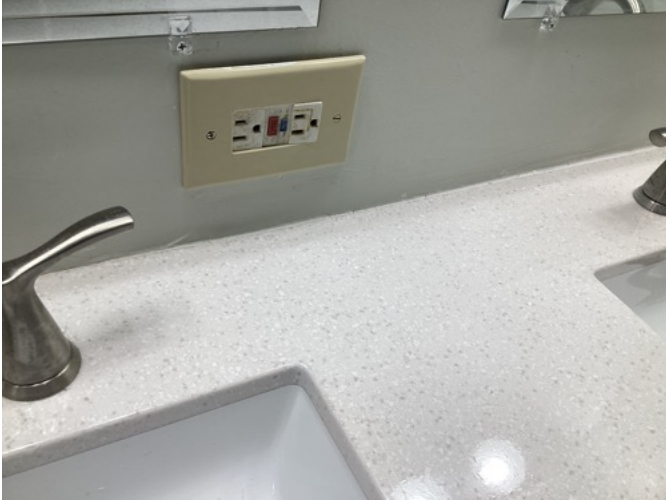
**Electrical Conditions****9.7) Electrical Conditions**

Master bathroom, Loose receptacle. Have this repaired by a licensed electrician to prevent electrical shock injuries.

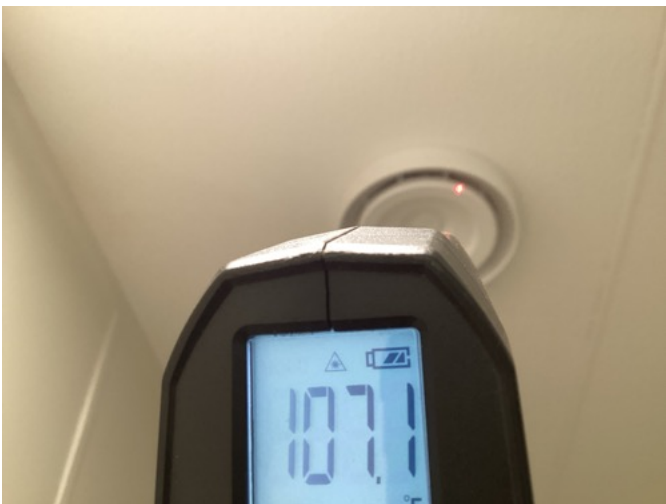
**9.9) Vent Fan Conditions**

Vent fan is clogged and or debris coming from vent fan when turned on. Recommend cleaning for improved functionality and efficiency.

The heater appears on of vent fan is vented into the attic. Further evaluation by a licensed electrician for proper functionality.

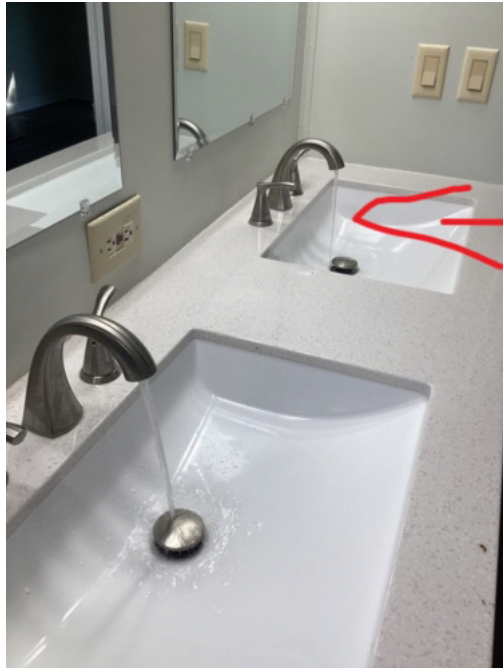
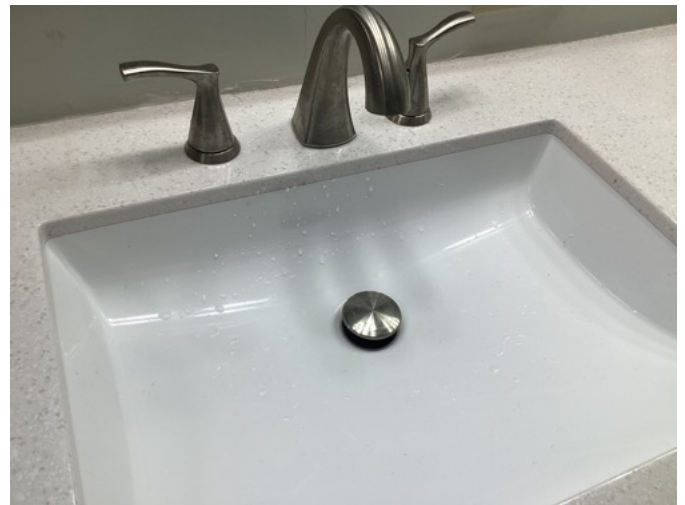
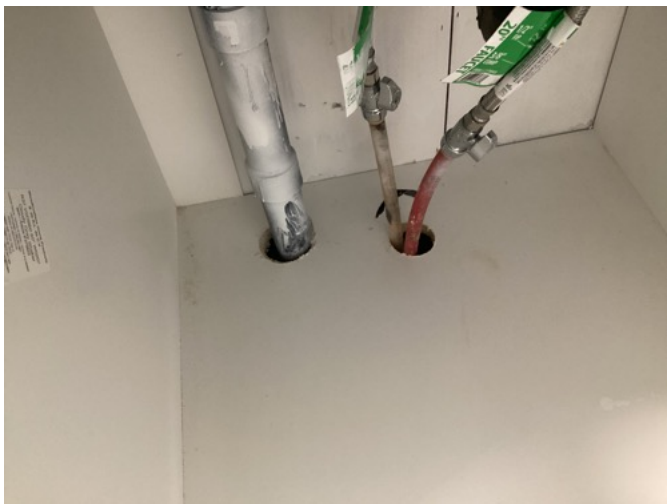
**9.11) Sink Conditions**

Master bathroom, Openings were noticed around pipes going through the wall and or flooring. Seal openings to prevent moisture intrusion and pest activity.

Master bathroom, The sink drain stopper did not operate or was missing in bathroom. Repair this for proper functionality.

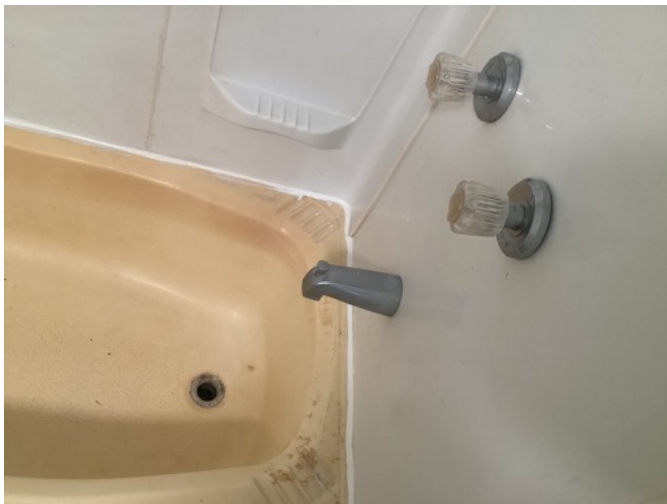
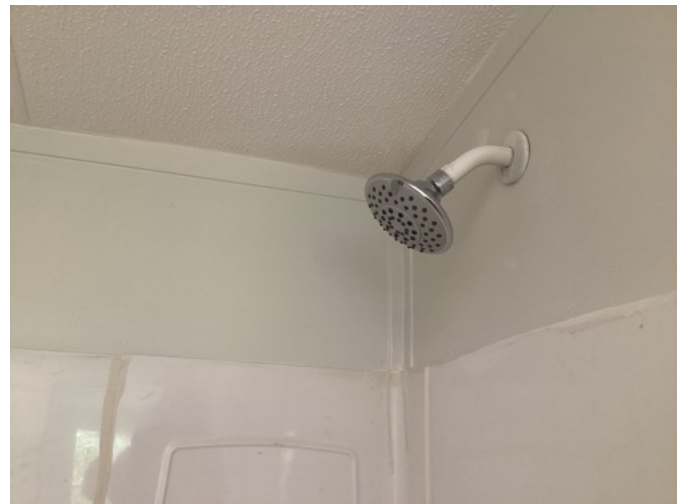
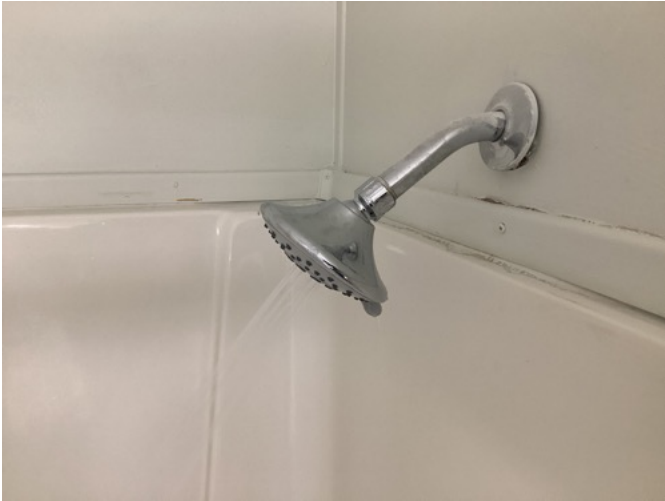
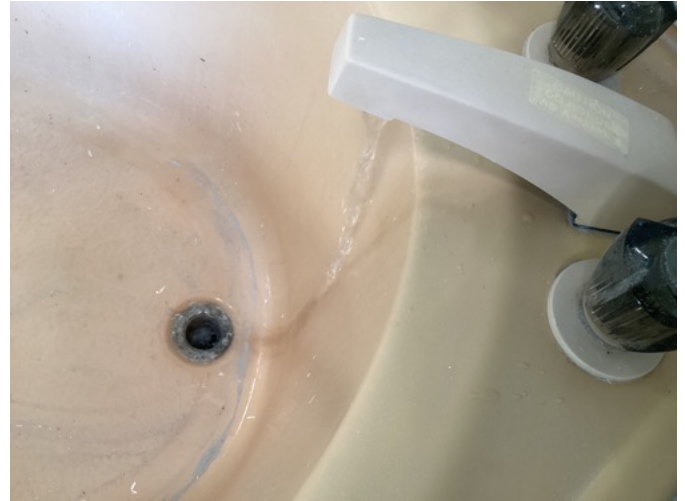
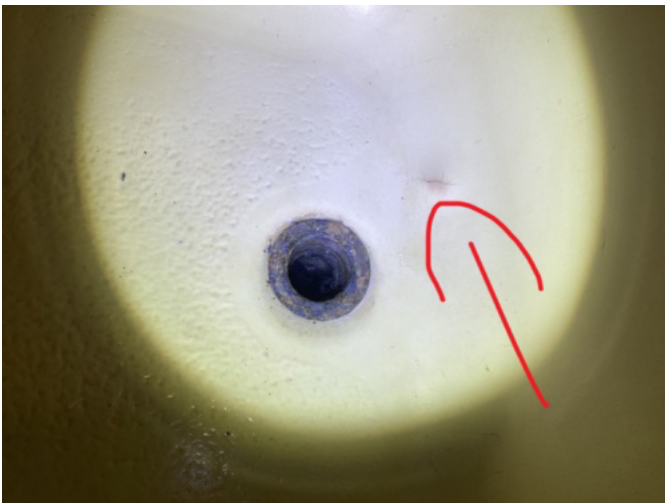
**9.12) Shower - Tub Conditions**

The faucet, tub sprout, pipe that shower head is attached to, shower assembly, and / or plumbing was loose at the wall in hallway bathroom. Have this repaired by a licensed plumber for proper functionality and to prevent damage.

Tub / shower stoppers were not working or missing. Have this corrected by a licensed plumber for proper functionality.

Master bathroom, Water leaking from connection and or shower arm or head. Repair for water conservation and proper functionality.

Master tub, Visible evidence of low water pressure was observed at the tub cold bathtub faucet. Some repair may be needed by a licensed plumber for proper functionality.

Master bathroom, Hallway bathroom tub has damage. Further evaluation by a licensed plumber for proper functionality and to prevent water related issues.

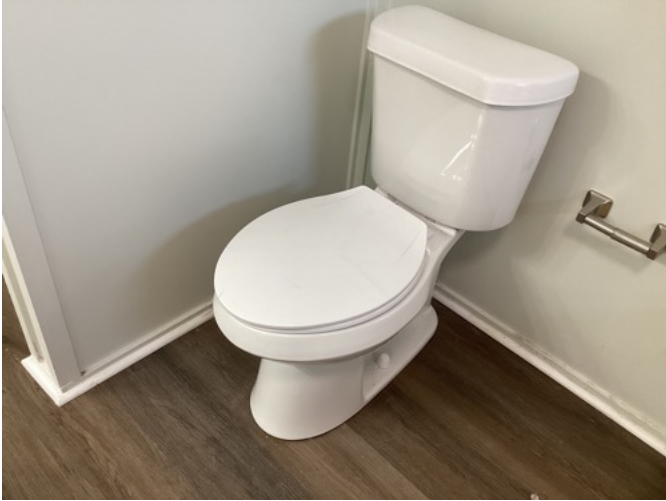
### 9.13) Toilet Conditions

The toilet was loose and or rocks at the floor in master bathroom. Recommend securing / repair as needed. While this condition is somewhat common, it can increase the likelihood that some water penetration may have occurred at the base / wax seal area of the floor.

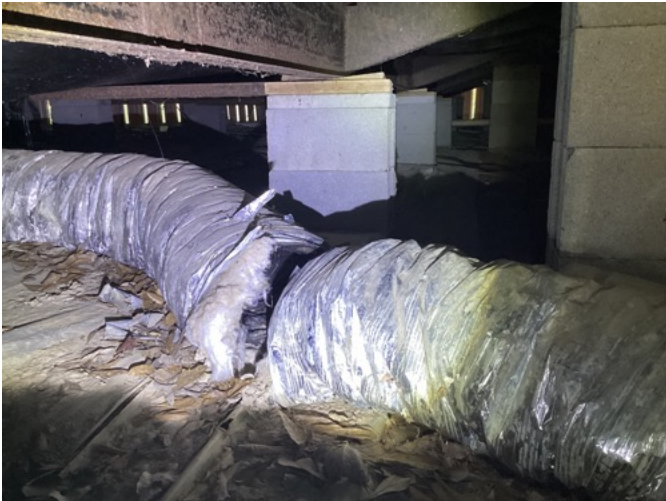
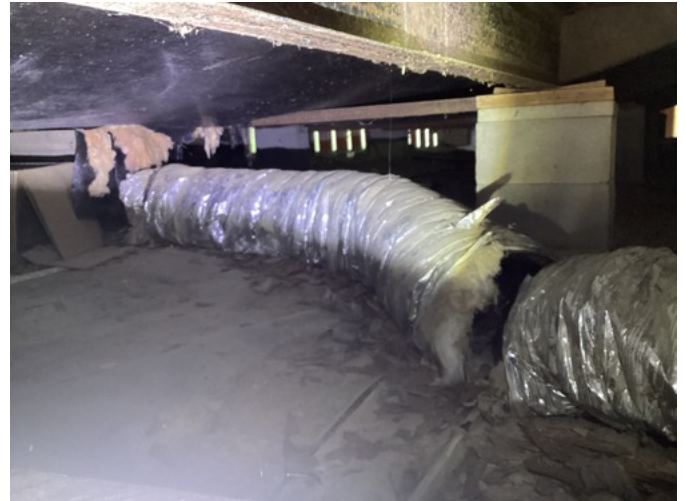
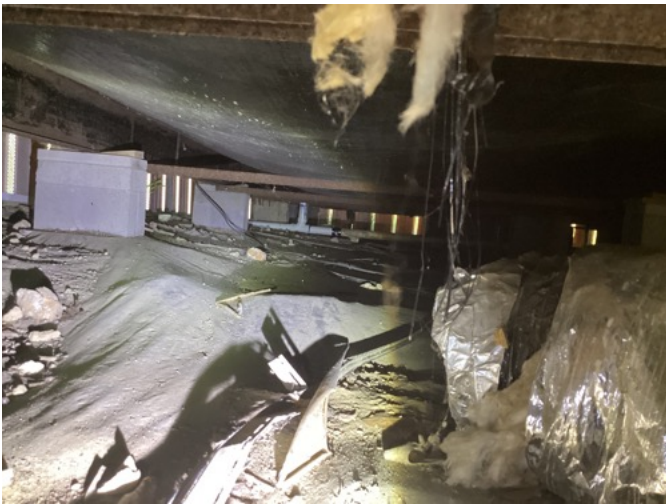
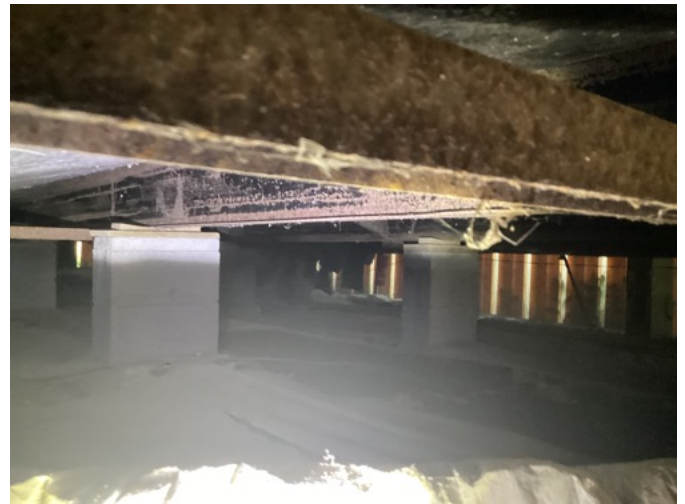
**11.1) Foundation Conditions** AS

The base of the crawl space had no plastic installed or not installed in all areas. Client should consider installation of a plastic sheet vapor barrier over the soil to reduce moisture in the crawl space.
